STRUCTURAL STABILITY REPORT OF ACADEMIC BUILDING OF BHONSALA MILITARY SCHOOL GIRLS

Report No. CIPL/NSK/R/082506/25

SUB: - Structural stability report for Academic Building of Bhonsala Military School Girls for Central Hindu Military Education Society, Nashik -422005.

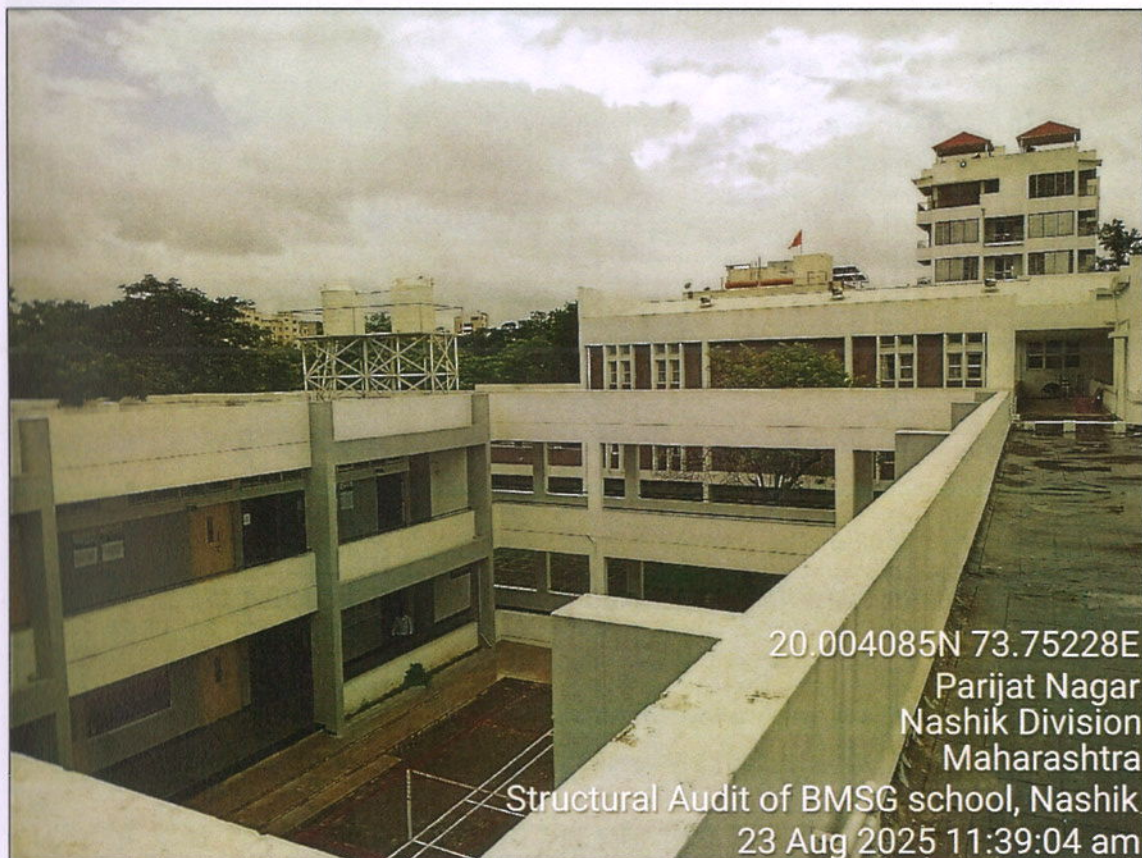
Photo No. 1- Internal View of School

1. The dampness in the peripheral walls was observed at few locations.
2. The vegetation on the terrace level noted at few locations.

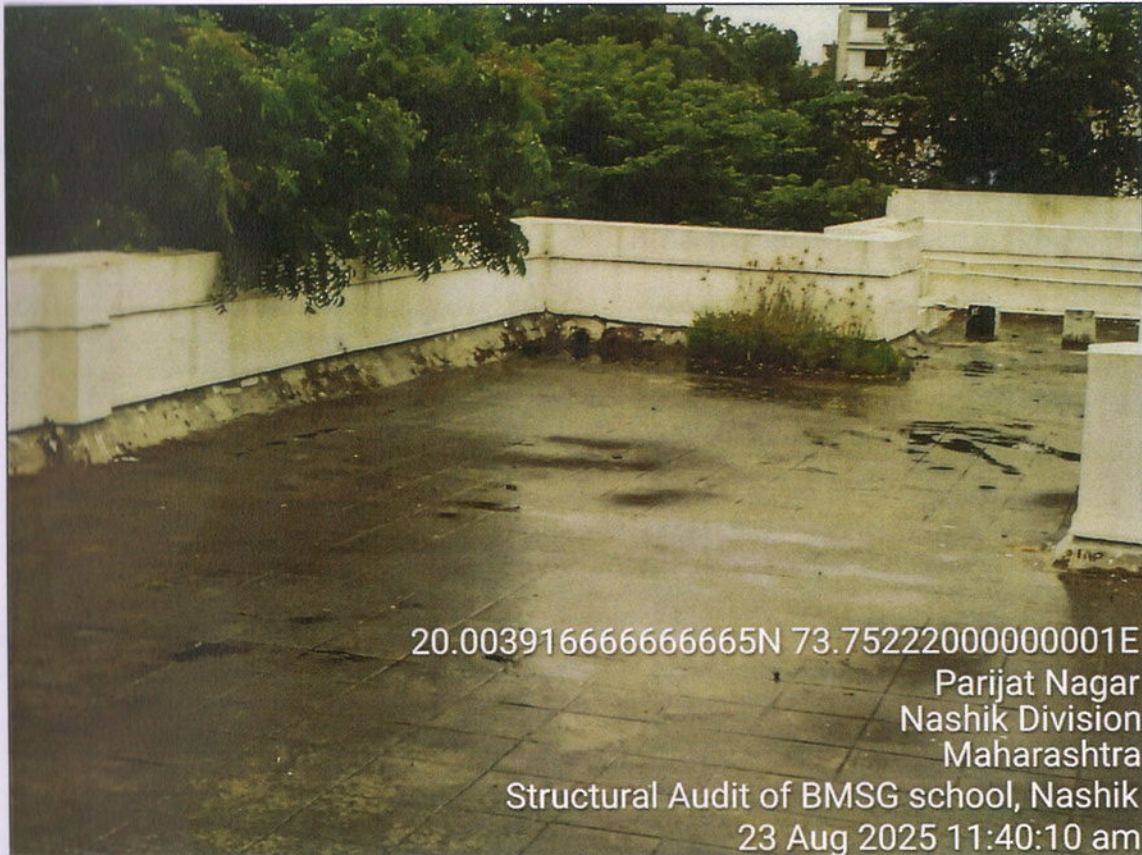
Photo No. 2- Vegetation on the terrace level at few locations.

1. As per the detailed visual inspection, the existing structure is safe for the vertical loads as per IS 875 part (i) and (ii) for the period of 5 years after which the stability shall be re-accessed to ascertain any damages in between period.
2. However, following recommendations for the safety and feasibility of the structure are advised.
 - a. The vegetation any part of the structure shall be unrooted immediately to avoid ir-reparable damages to the structure.
 - b. Any damage to the drainage pipelines shall be repaired immediately to avoid dampness and odour in the structure.
