STRUCTURAL STABILITY REPORT OF ACADEMIC BUILDING OF BHONSALA MILITARY SCHOOL GIRLS

Structural Audit of BMSG school, Nashik

Report No. CIPL/NSK/R/082506/25

SUB: - Structural stability report for Academic Building of Bhonsala Military School Girls for Central Hindu Military Education Society, Nashik -422005.

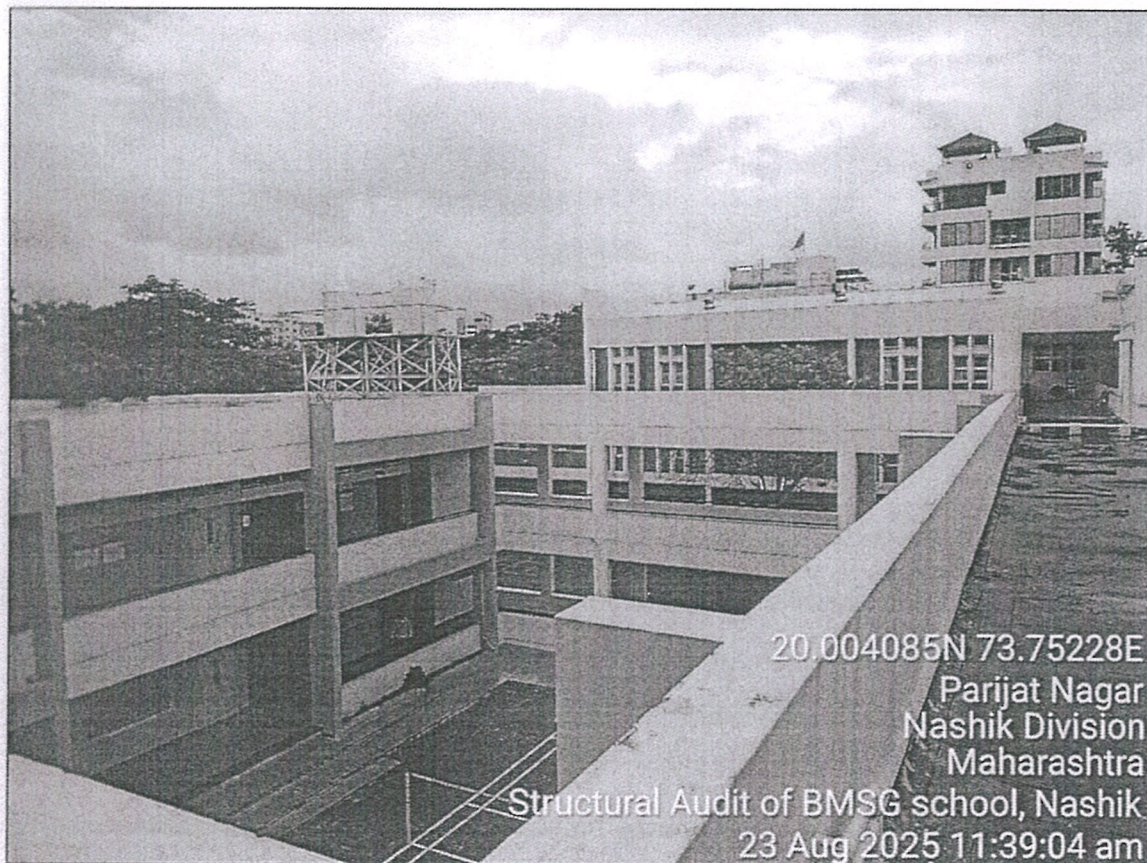
Photo No. 1- Internal View of School

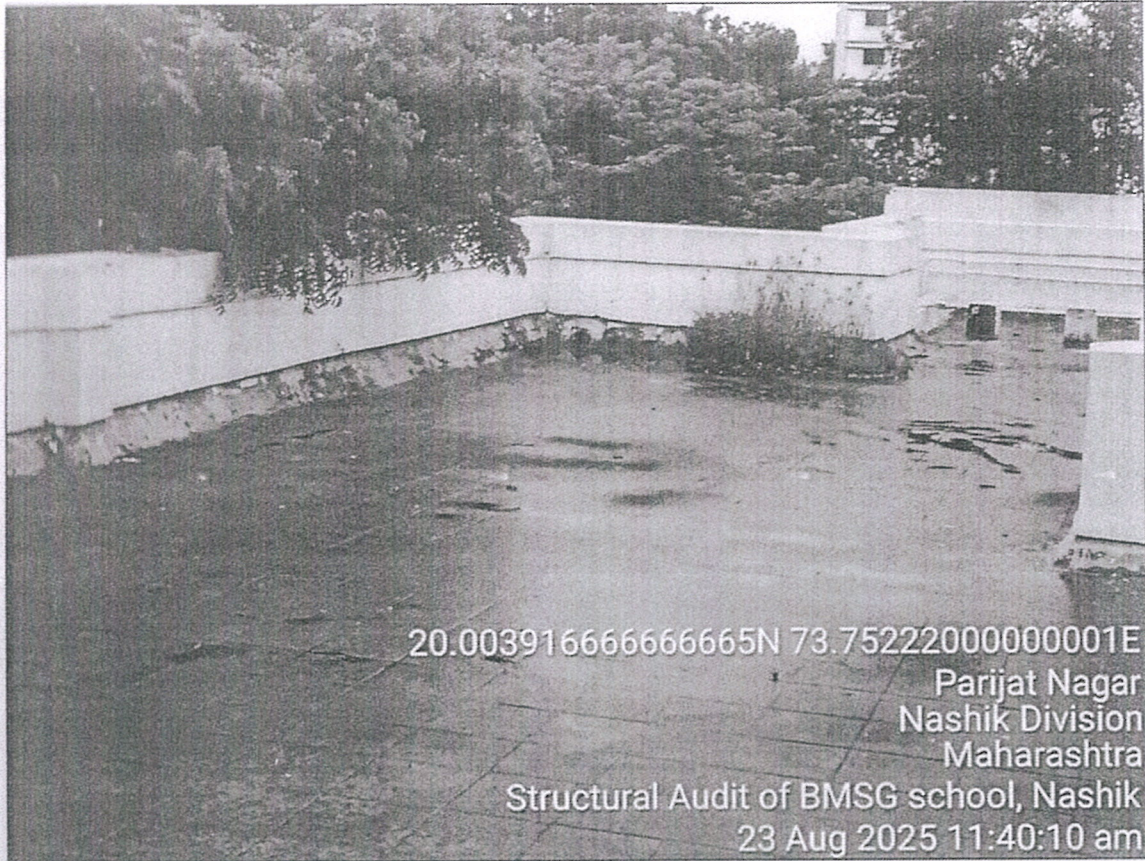
1. The dampness in the peripheral walls was observed at few locations.
2. The vegetation on the terrace level noted at few locations.

Photo No. 2- Vegetation on the terrace level at few locations.

1. As per the detailed visual inspection, the existing structure is safe for the vertical loads as per IS 875 part (i) and (ii) for the period of 5 years after which the stability shall be re-accessed to ascertain any damages in between period.
2. However, following recommendations for the safety and feasibility of the structure are advised.
 - a. The vegetation any part of the structure shall be unrooted immediately to avoid ir-reparable damages to the structure.
 - b. Any damage to the drainage pipelines shall be repaired immediately to avoid dampness and odour in the structure.
